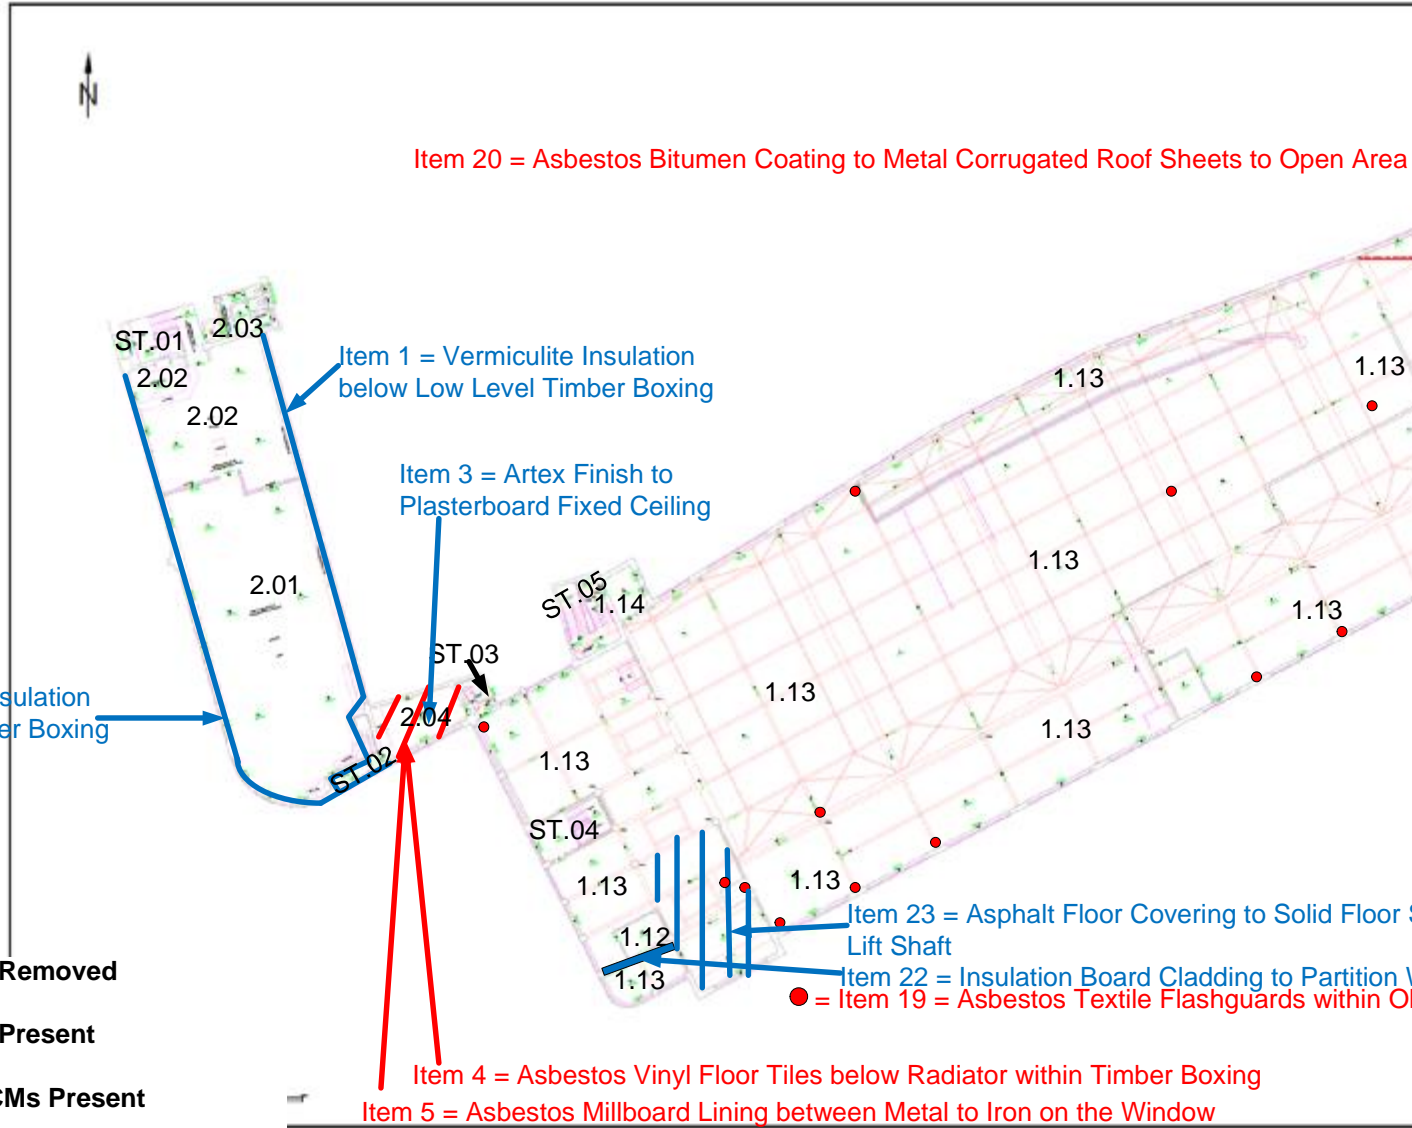
Item 20 = Asbestos Bitumen Coating to Metal Corrugated Roof Sheets to Open Area 1.13

Item 1 = Vermiculite Insulation below Low Level Timber Boxing

Item 3 = Artex Finish to Plasterboard Fixed Ceiling

Item 23 = Asphalt Floor Covering to Solid Floor Slab & Section of Wall below Lift Shaft

● = Item 19 = Asbestos Textile Flashguards within Old Electrical Boxes

Item 4 = Asbestos Vinyl Floor Tiles below Radiator within Timber Boxing

Item 5 = Asbestos Millboard Lining between Metal to Iron on the Window
